# HİLAL-2 WIND POWER PLANT PROJECT

## BAT ASSESSMENT REPORT

Version	Revision	Date	Prepared by	Checked by	Approved by
Final	C.1	28 June 2016	Şafak Bulut Mammologist & Bat Expert	Turgay Eser Environmental Engineer	G. Ozenirler Environmental Engineer M.S.

Project No: 16/007

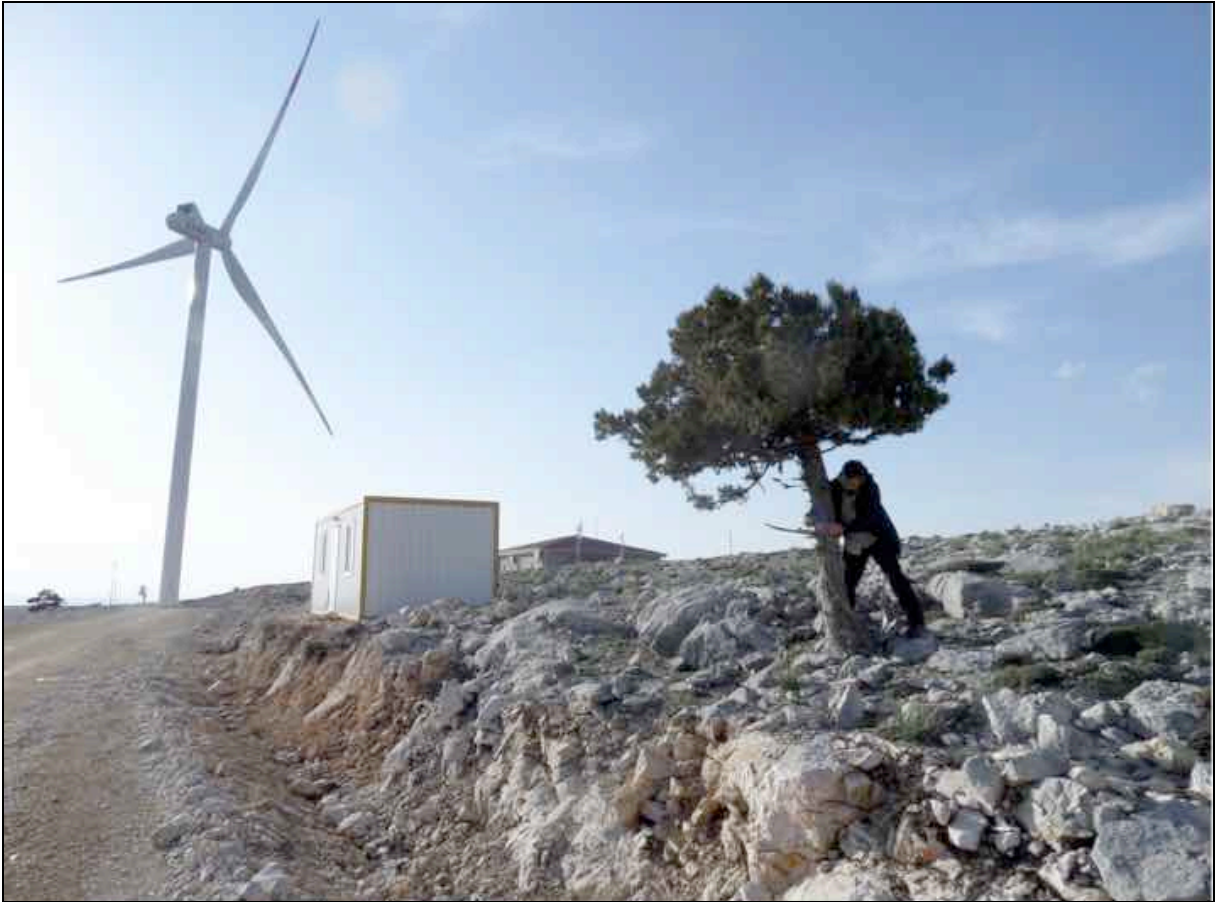
Photo 2. Installation of Bat Detectors by the 2U1K Team

Bat detection equipment used during the site study include detectors recording bat sounds at night time (BatBox Griffin and Pettersson D500X), detection equipment that converts bat sounds to audible frequency (BAAtBox Duet) and another type of bat detector that records in the forms of time expansion (Petersen D 240X).

BatBox Griffin and Pettersson D500X are full-spectrum equipment and recording time can be set. Recording times have been set to record between sunset and sunrise. Recording periods are shown in Table 1.

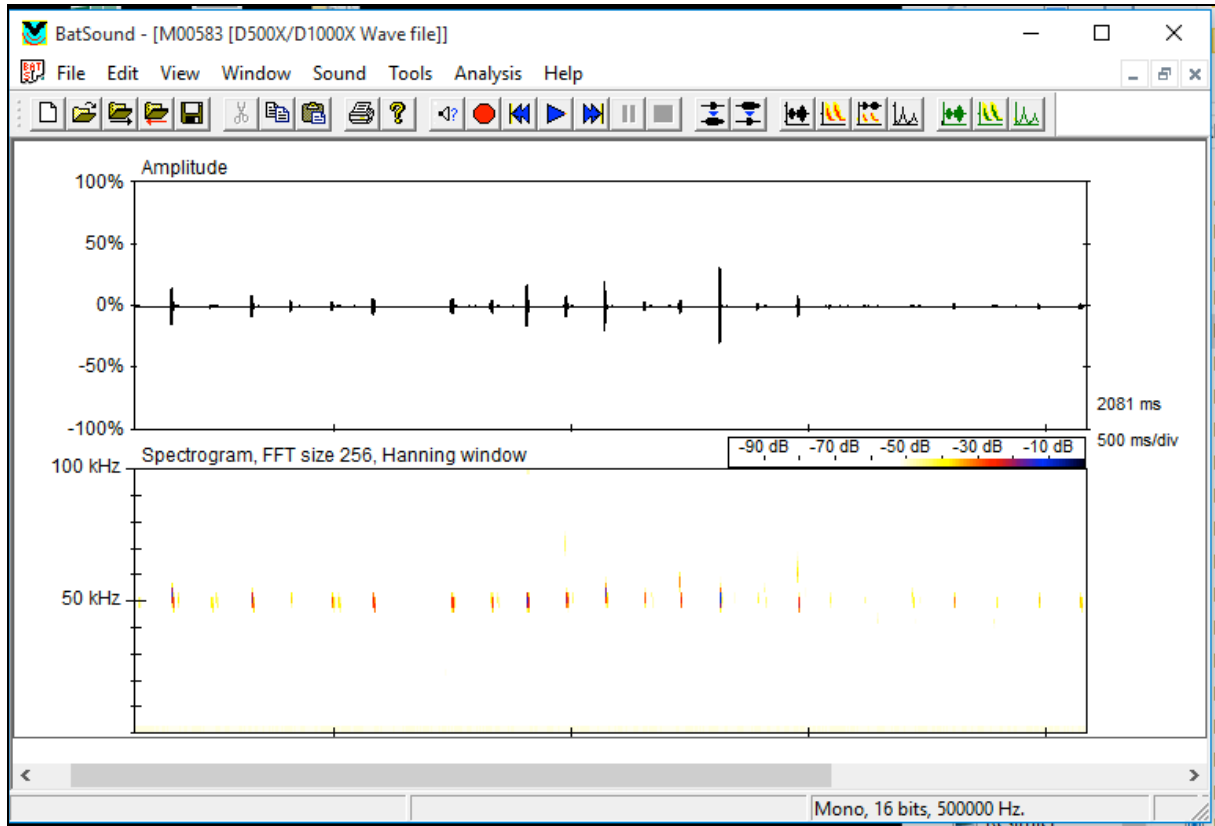
Figure 2. Batsound Software Version 4.2 Used in Analysis of Recorded Sounds

Special software has been used for showing graphical and sonogram presentations of recorded sounds (BatSound real-time spectrogram analysis software, version 4.2; BatScan version 9.8). Analysis of recorded sounds with these software are shown in Figure 2 and Figure 3.

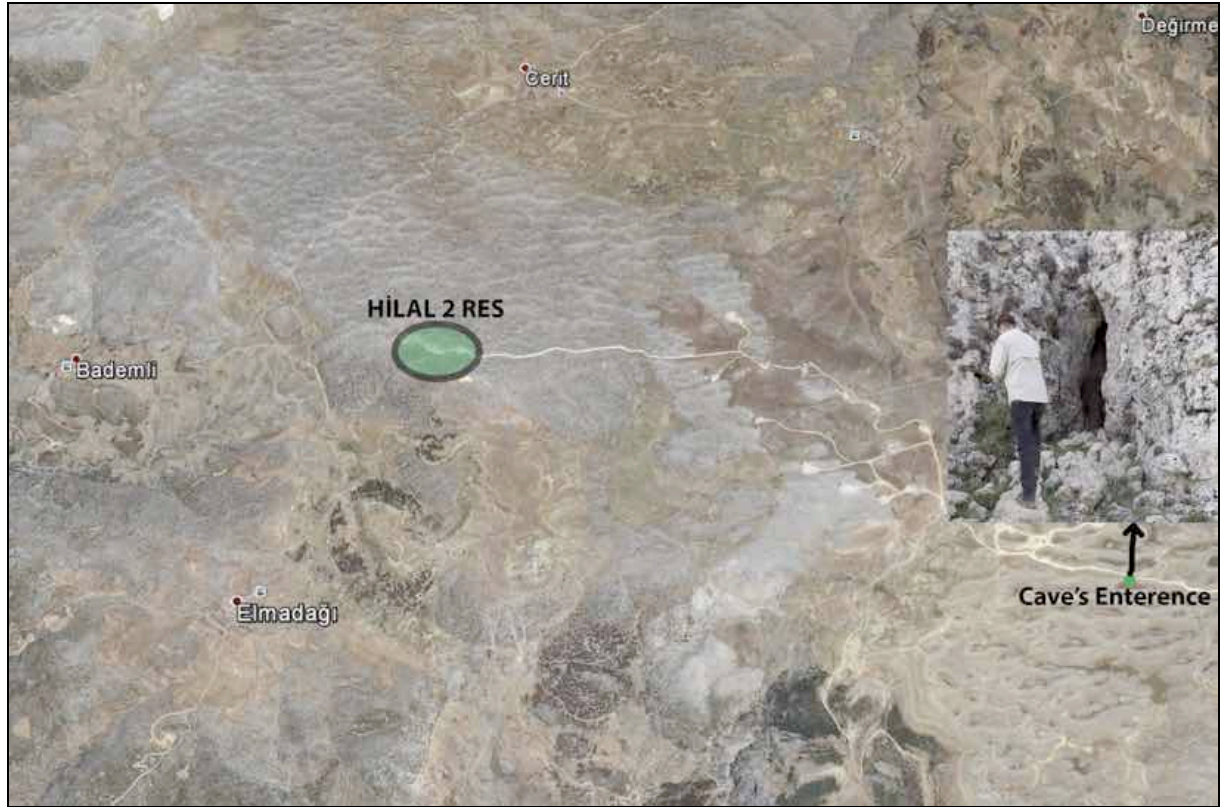
Figure 4. Location of the Cave and the Project Area

During the site assessments, conversations with local people have led to identification of caves and rock deposits (See Figure 4). The cave that is located at about 6 km to the Project area is not within impact zone of the Project. Furthermore, no bat colonies or species or feces have been identified in the cave (See Photo 3).

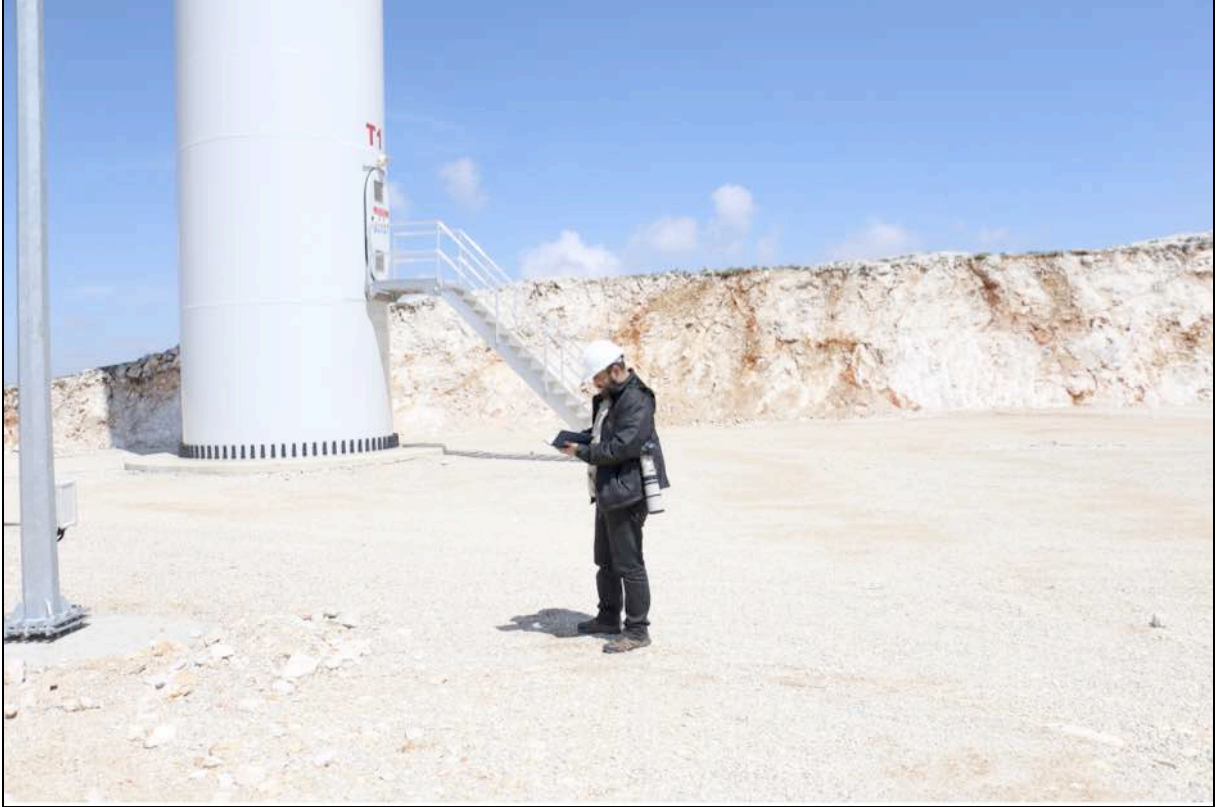
Photo 4. Carcass Search (Turbine No: 1 and Surroundings)

Carcasses have been searched in order to see dead bats from fatalities due to possible collisions and pressure changes. However; raptors, carnivorous mammals and necrophagous reptiles make it difficult to find any carcasses. Thereby it is more possible to see carcasses on concrete grounds at early times of the day.

In this respect, early morning searches on concrete grounds have been performed. Yet no carcasses were found. Site personnel was also interviewed and no carcasses were seen.

stage, based on studies by bat specialists during migration periods. However, bat migration routes are not known in the country yet. It can be stated that no mass fatalities occurred around the site. The Site personnel should continue with carcass search and at migration periods and low wind speeds, and site personnel should be trained on carcass search.

Carcass search should be performed within a diameter of 50 m around each turbine early autumn during the migration period and for 5 days, as suggested by EUROBAT.

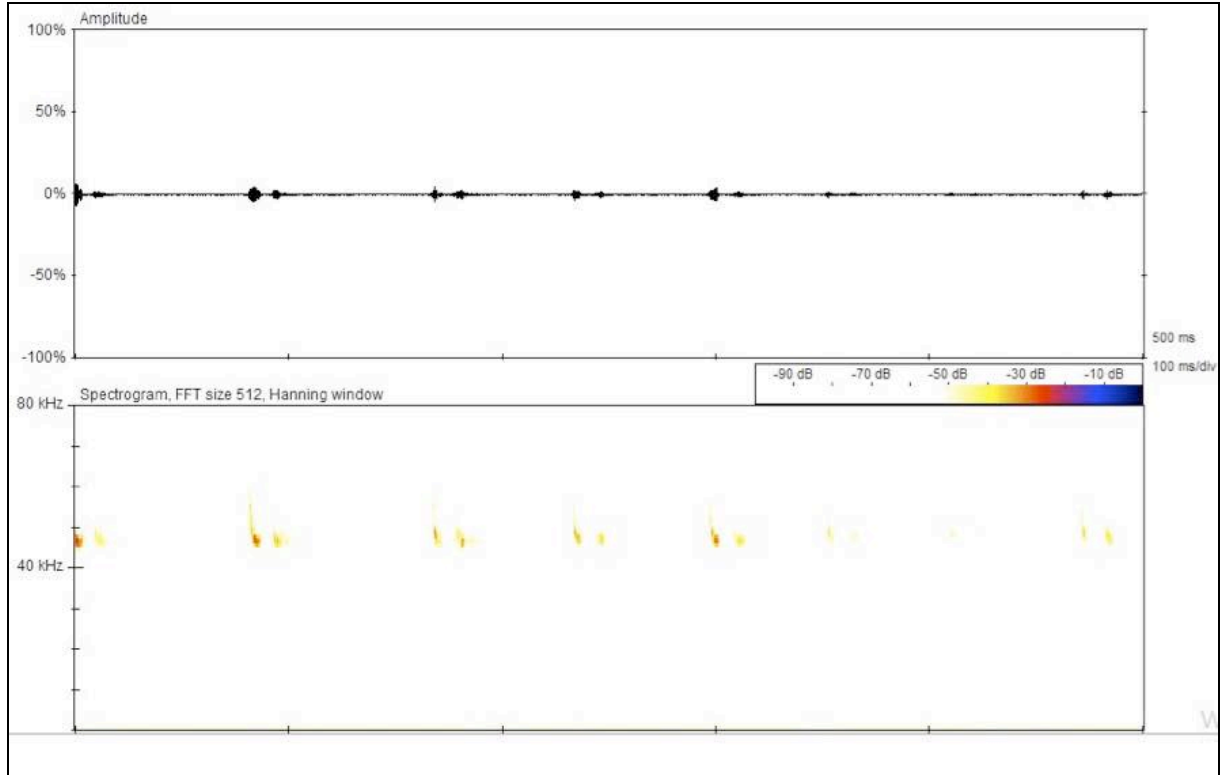
Figure 5. Sonogram Belonging to *Pipistrellus pipistrellus* (Common Pristerelle)

Full spectrum bat recording equipment have been used for a night time assessment. As a result of 22-hours recording, only one bat specie was detected: *Pipistrellus pipistrellus* detected at 01:28, possibly attracted by the lighting at the switch yard.
